Manhole Inspection Summary

Manhole # S65G__004MH

Insp Date: **3/14/08 10:22 AM**

Location Address: **400 El Rino St.**

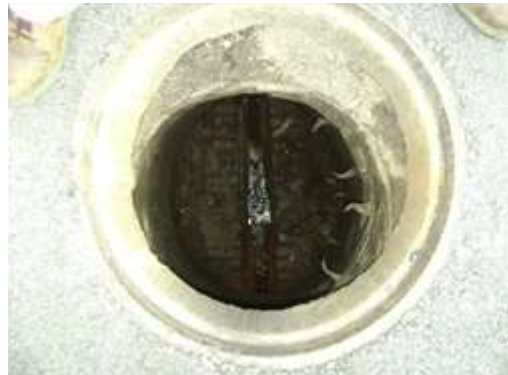
Top View

Frame Offset: **4** (in.) Condition: ☐ Sound ☒ **Cracked** ☐ Leaks

Condition: ☐ Sound ☐ Cracked ☐ Root Intrusion ☒ **Loose Brick** ☒ **Deteriorated**

Infiltration: ☐ None ☒ **Joint** ☒ **Cracks** ☒ **Mortar** ☐ Roots ☐ Wall
